Revision Guide for AMD Athlon™ 64 and AMD Opteron™ Processors

Publication # 25759	Revision: 3.73
Issue Date: October 2007

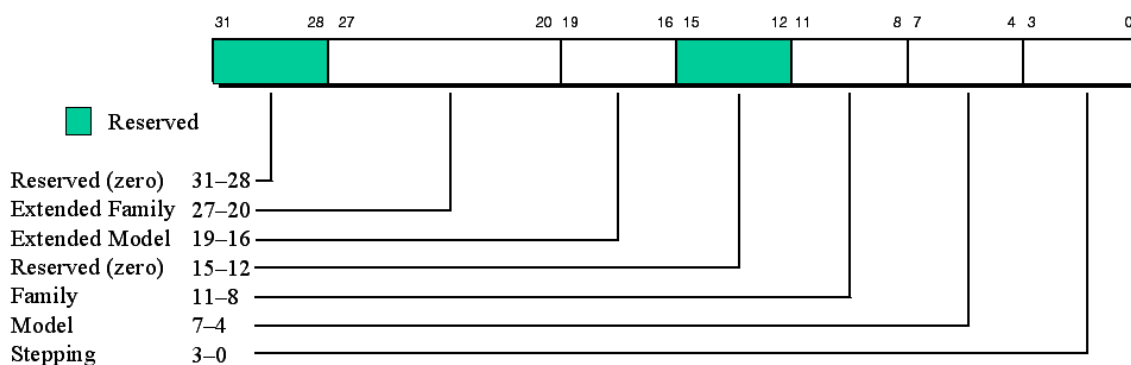
Figure 1. Format of CPUID Value Returned by Function 1

Figure 1 shows the format of the value returned in EAX by CPUID Function 1.
